**DEPARTMENT OF TRANSPORTATION**

Contract #: 04-0120F4Cty: SF/ALA Rte: 80 PM: 13.2/13.9File #: 99.28**WELDING INSPECTION REPORT****Resident Engineer:**Siegenthaler, Peter**Address:** 333 Burma Road**City:** Oakland, CA 94607**Report No:** WIR-019315**Date Inspected:** 06-Jan-2011**Project Name:** SAS Superstructure**OSM Arrival Time:** 700**Prime Contractor:** American Bridge/Fluor Enterprises, a JV**OSM Departure Time:** 1900**Contractor:** Zhenhua Port Machinery Company, Ltd (ZPMC) Chanxing Island**Location:** Shanghai, China

**Bridge No:** 34-0006**Component:** OBG Segment**Summary of Items Observed:**

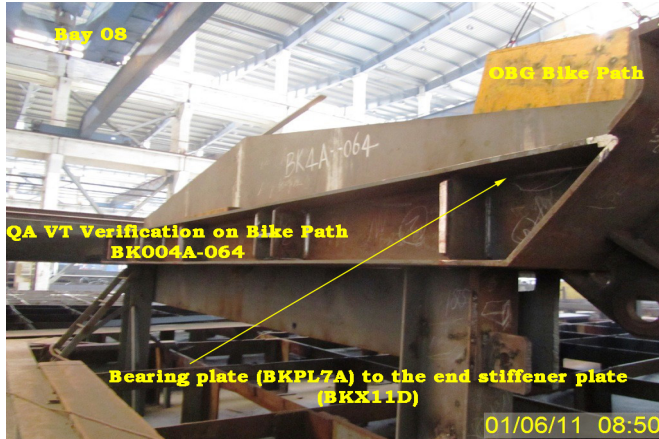
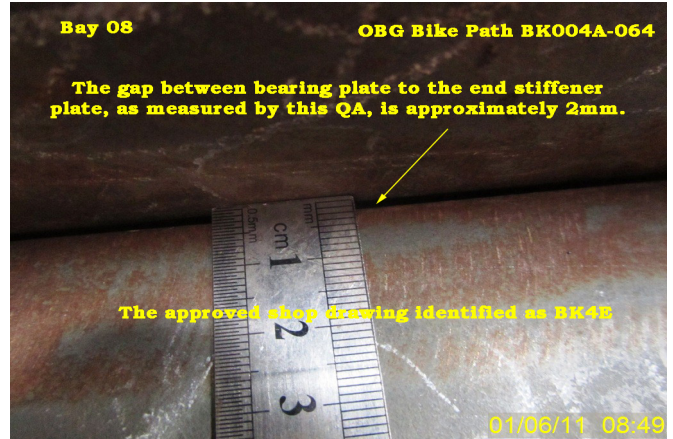
This QA inspector randomly performed VT of the area previously tested and accepted by ZPMC Quality Control personnel. The members are identified as OBG Bike Path BK004A-064. The weld designations reviewed on before fit-up the closure plate welds. See the attached picture.

Description of Incident: During Quality Assurance Visual Inspection (VT) verification of the OBG Bike path (BK)-BK4A-064, this Caltrans Quality Assurance (QA) inspector observed that the gap between bearing plate (BKPL7A) to the end stiffener plate (BKX11D) within the maximum tolerance specified in AWS D1.5. The approved shop drawing identified as BK4E, Section N-N, specifies that this joint is tight fit and no weld. The gap between bearing plate to the end stiffener plate, as measured by this QA, is approximately 2mm. The bearing plate and to the end stiffener plates are identified as BKPL7A and BKX11D respectively. VT inspection has been carried out prior to installation of the BK end closure plates BKPL8. OBG BK4A-064 is currently located in the Subassembly bay-8. The Notice of Witness Inspection Number (NWIT) is 08076. See the attaché pictures.
